Laboratory Experiment on Failure of Embankment

Adrin Tohari*, Makoto Nishigaki ** and Mitsuru Komatsu*

Failures of railway embankments in Japan usually occur during rainfall period due to the rise of water level in the embankments. Laboratory experiments were carried out to elucidate the initiation of failure of embankment under the rise of water level. The changes in pore-water pressure were monitored during the rise of water table and at the initiation of failures. The experiment results showed that main failure of embankment was initiated by development of localized unstable area at the toe of the embankment models during the rise of water level. This indicates that failure of embankments was a consequence of instability of the toe of the slope induced by saturation process under drained condition.

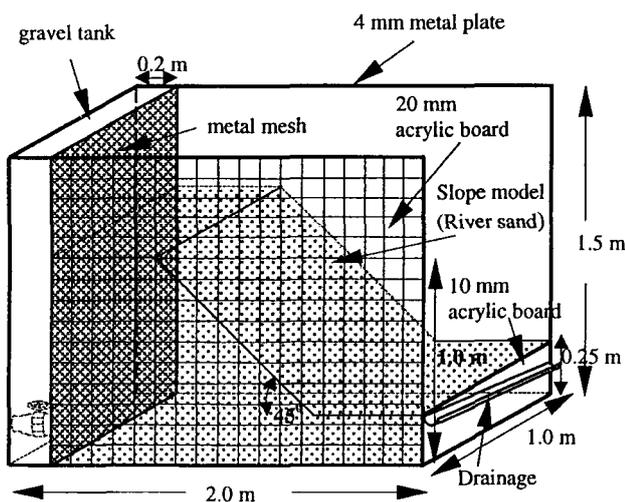
Fig. 1 Slope failure tank

The slope failure tank as the basic apparatus and the profile of the embankment model are shown in shown schematically in **Fig. 1**. This large metal tank was designed to accommodate 1-m high soil slope that could be brought to failure by seepage of water towards the toe. The dimensions of embankment model were chosen to reduce the effects of side friction limit (width and height ratio of 1.0), while keeping the volume to practical. The slope angle of 45° is close to the angle of repose of 50° . To generate an impervious boundary at the end of the slope model, a 1 cm acrylic board of 25 cm height was secured at the down slope end. The properties of the embankment models for each experiment are given in **Table 2**.

The tank was facilitated with an acrylic observation window for pressure and deformation facilitated with embankment profile, grids, transducer holes and tracer injection holes at several points. During experiments, blue tracers were injected through the holes using ordinary syringes to visualize the flow lines within the embankment profile.

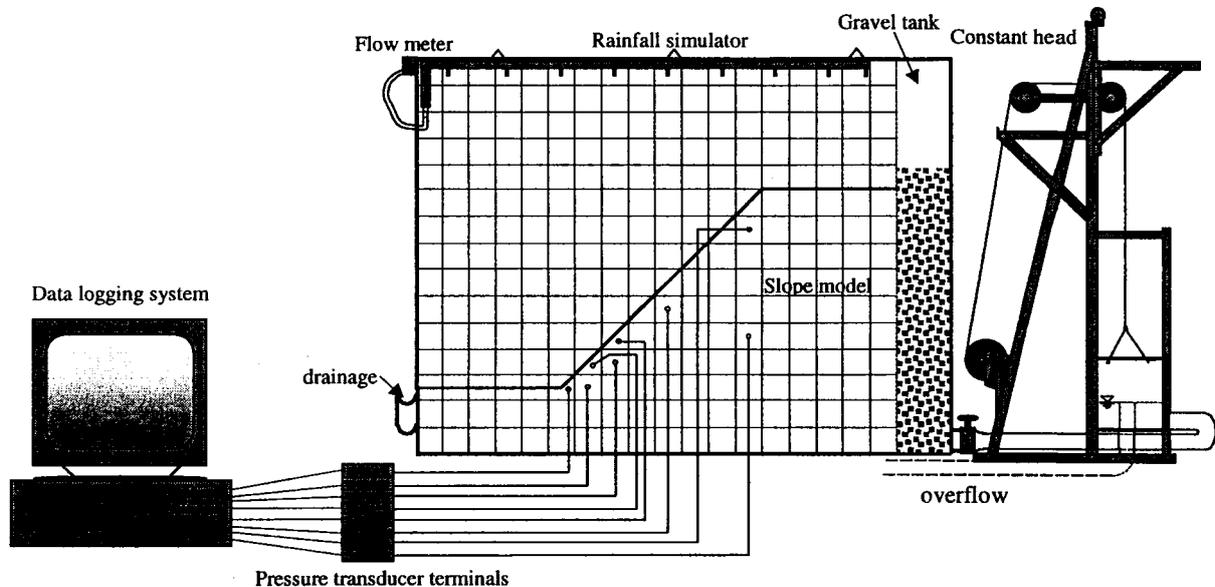
Fig. 2 Overview of set up of instrumentation

Eight pore-water pressure transducers were mounted in custom fitting through the observation window with porous cup submerged about 5mm within the soil itself to ensure effective measurements of rapid change in pore-water pressure. Each of the transducers was logged at approximately 1minute intervals. **Fig. 2** shows the configuration of pressure transducers.

profile (Table 2). Overall view of the tank and constructed slope profile is shown in Fig. 2.

A video camera was set up in front of the slope face to give a better view and complete record of saturation, failure initiation and movement. A 35-70 mm auto focus camera was used to record the flow lines, slope profile before and after failure, and displacement of sliding block.

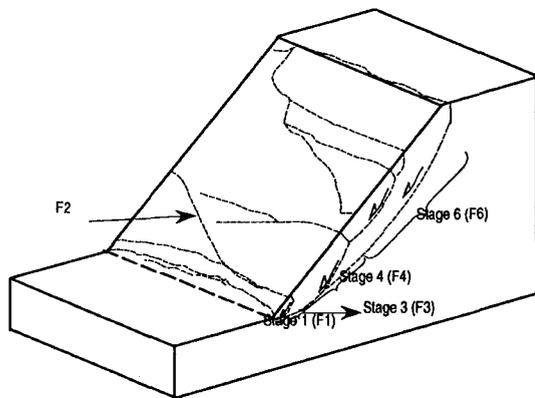
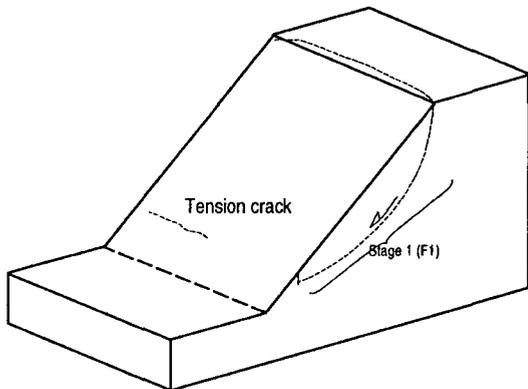
Fig. 4 Overall failure sequences

Experiment 1

Experiment 2, 3

dimensional nature of the overall failure processes are illustrated schematically in Fig. 4.

Failures of each embankment model commenced by toe saturation and development of tension crack at the toe of the embankment. In experiments 2 and 3, tension cracks were also developed at the top of the embankment before toe saturation. In experiment 1, retrogressive sliding was preceded by localized shallow failures at the toe following the development of seepage face. The next sliding did not initiate the previous slab had virtually come to rest and until the next rise of water level.

For comparison, development of at tension crack at the toe and the top of the slope generated instability to the whole portion of the slope in experiments 2 and 3. Main failure took place a few seconds after toe failure.

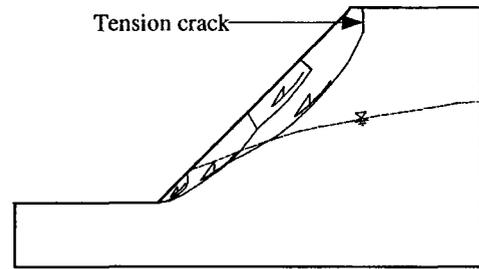
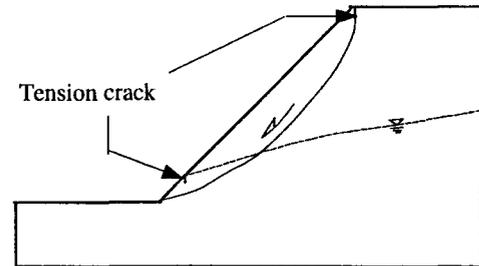
Fig. 5 Summary of failure modes for all experiments

Retrogressive non-circular sliding (experiment 1)

Shallow non-circular sliding (experiment 2, 3)

Failure modes observed in all of experiments are summarized in Fig. 5. Most dominant mode of failure deduced from the experiments is shallow non-circular

slide, frequently retrogressive with failure surface cut through the slope toe.

Although placement conditions for all experiments were as nearly identical as possible, the failure modes were obviously different. It is believed that mode of raising water level in the slope controlled the failure modes. Experiment 1 failed by shallow retrogressive sliding rather than non-circular slide apparent in experiments 2 and 3. However, it is interesting to note that all failures were preceded by toe failure. This indicated that the occurrence of failures observed in all experiments was due to the loss of lateral support resulting from the earlier stage of failures.

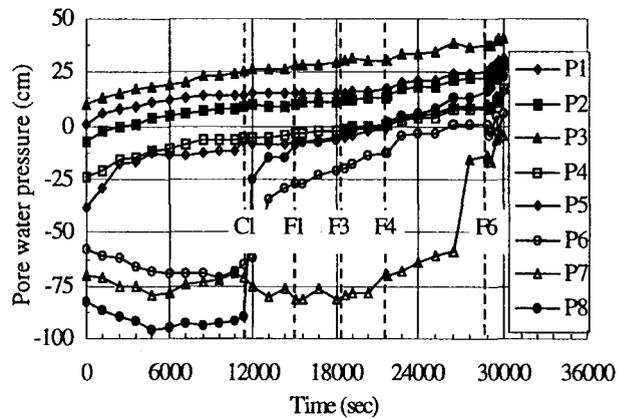
Fig. 6 Overall pore-water pressure changes, experiment 1

Pore-water pressure records during experiment one showed that pore-water pressures increased slowly. Near the slope surface transducer located near the toe, (P3) indicated the progress development of seepage face throughout the experiment that contributed to the occurrences of most failures (Fig. 6). For comparison, the advancing wetting front resulted initially in significantly rapid increase in pore-water pressures to positive value throughout experiments 2 and 3 (Fig. 7 and 8). Transducers located near the slope surface (P1-P3) showed pore-pressure increases to positive values prior to the occurrence of slope failure. This gave the

indication that failure initiation could be associated with the development of seepage face.

Pore-water pressure records during each experiment, as shown in Fig. 6 to 8, increased throughout the experiments in response to the advancing wetting fronts. Saturation is indicated by initially negative pore-water pressures increasing to zero. It should be noted that times representing initiation of the different stages of failure
