Development of image analysis for  
detection of defects of BGA by using  
X-ray images

## Development of Image Analysis for Detection of Defects of BGA by Using X-Ray Images

**Abstract-** In the surface mount technology, Ball Grid Array (BGA) has been used in a production of PC boards, because of their excellent characters such as high density of the lead pin pitch, better lead rigidity and self-alignment during re-flow processing. This paper deals with the development of image analysis for the detection of defects at BGA solder joints in PC boards by using X-ray images. In the conventional IC boards, it is possible to detect defects of solder joints by visual inspection, because the lead of IC package is set on its outside. However, we can't detect visually defects at BGA solder joints, because they are hidden under the IC package. In a production line, the inspection of BGA in PC boards depends on the function test of electric circuits in the final process. To improve a cost performance and the reliability of PC boards, an inspection of BGA is required in the surface mount process. Types of defects at BGA solder joints are solder bridge, missing connection, solder voids, open

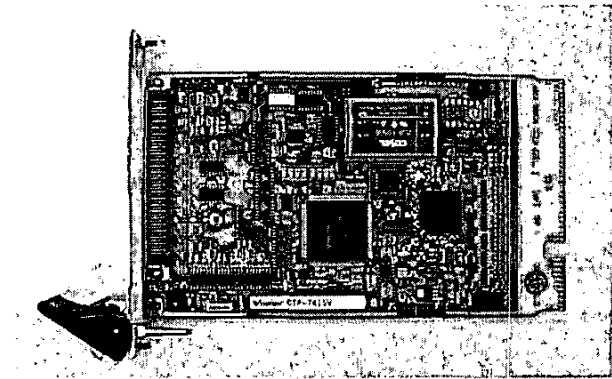
Fig.2 Photograph of one example of test board.

is CPU for main function in an electronics circuit. In the actual production line, we can find the test IC packages based on the final electrical circuit test. Fig.2 shows a photograph of one example of a test IC board. The thickness of PC board is 2 mm and it has six layers. IC package is mounted with BGA to the surface of the PC board. The solder ball diameter is 0.76 mm and the ball pitch is 1.27 mm and the number of BGA is two hundred and fifty six. The size of IC package is 27x27 mm. This test package does not pass the electrical function test. We consider this package has defects at BGA solder joints.

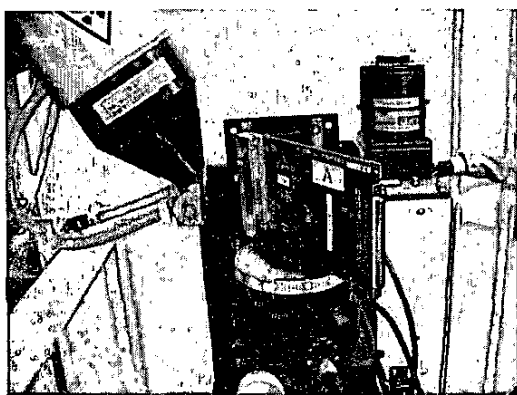
Fig.3 Apparatus for capturing X ray-image.

We try to capture X-ray image data by using an X-ray computed tomography (CT) [6]. To detect the inner defects, this apparatus was made to get computed tomography of mechanical parts such as a ball bearing, a cylinder and a battery. In these parts, the object for measuring is one unit. In this apparatus X-ray focus is 4  $\mu\text{m}$  and resolution is 68 lines pair/cm. The X-ray source and the detector of image are fixed. Besides, a test sample is set on the stage. Then, we can get images data by rotating the stage. We can adjust an image size of the test sample by changing the distance between the X-ray focus and the test sample. X-ray radiated from the focus transmits the test sample on the stage and comes to the detector. X-ray detection system consists of an image intensifier of 23 cm diameter and a CCD camera of four hundred thousand pixels. X-ray image is converted to the visible light by the image intensifier and image data is captured by 2/3 inch CCD camera as 8 bit gray levels.

ball to analyze the characteristics of an abnormal solder ball. It is impossible to get computed tomography data of each solder ball, because there are many solder balls in one IC package. Therefore, we have captured a projection X-ray image of a IC package. We set vertically the test package on the stage and rotated the test table from 0 degree to  $\pm 50$  degrees on every 10 degrees as shown in Fig.3. By rotating the test package, we can take X-ray image with inclined penetration and attempt to detect BGA bridges from different direction. When the angle of inclination is over 50 degrees, we can not distinguish each solder balls, because of overlapping of images. The condition for capturing image data is as follows.

X-ray tube voltage: 185 KV, X-ray tube current: 160mA, exposure times: 30 seconds.

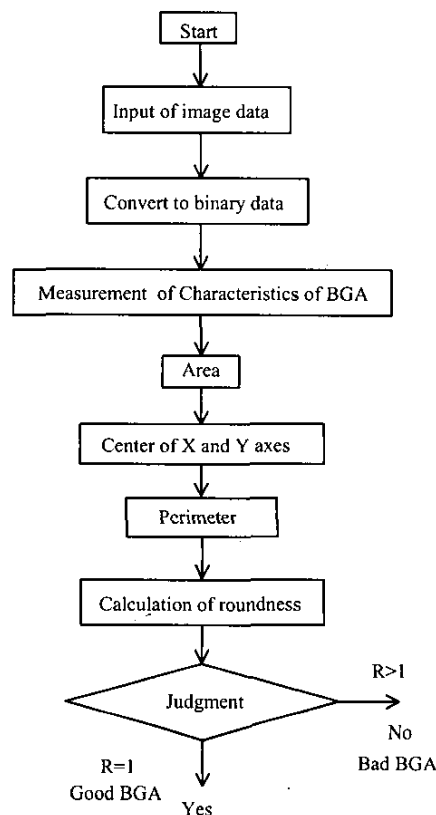
Fig.4 Flowchart of image analysis.

Fig.4 shows a flowchart of an image processing for X-ray image data obtained by the above apparatus. Image data is an input data to the personal computer for analysis. It is converted to the binary data to detect accurately the counter of a solder ball. Threshold level is determined based on signal profile on

horizontal line. We selected 54 count gray levels as the threshold level and converted to black and white image data to measure accurately the following factors of BGA. After labeling, first we measure the area of each solder ball and center of X axis and Y axis. Next we measure the perimeter and the radius ratio of each solder ball. A normal pattern of a solder ball is a circle. If a solder ball has defects such as bridge, the shape of the object separate from a true circle. In the case of solder bridges, two solder balls are shorted with the narrow path and we can observe the different pattern such as connected with the bridge.

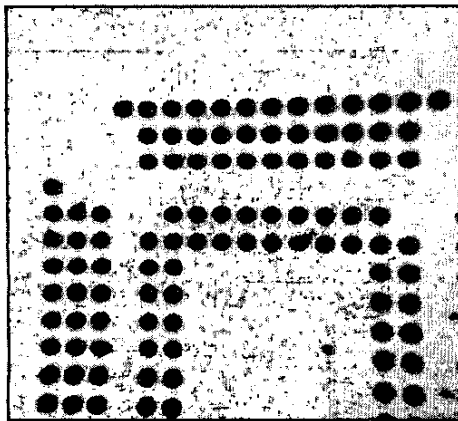
Fig.5 Original image data (minus 37 degrees).

Fig.5 shows an example of the original image data series captured by the above apparatus with inclined penetration of X-ray (inclination angle : -37 degrees). In this picture, we can observe one abnormal BGA. We analyzed this image data based on the above method. Fig.6 shows the binary image data after labeling. Fig.7 shows the radius ratio of each solder ball. Fig.8 shows the roundness. The roundness is one for the true circle by equation (1). The actual radius ratio and the roundness of a solder ball is a little over one as shown in Table 1. This table shows an example of the result of the image analysis.

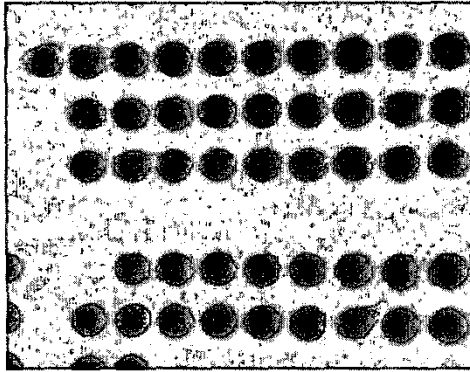
Fig.9 Original image data (minus 43 degrees).

By rotating this test board, we can find another solder bridge with the inclination angle of minus 43 degrees, as shown in Fig.9. Fig.10 shows the binary image data after labeling. We can observe that the bridge connects two balls. This bridge is observed in the inclination angle between minus 40 degrees

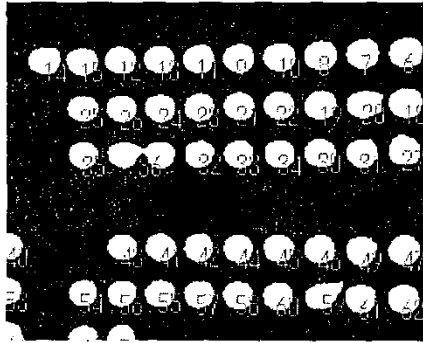
Fig.10 Binary image data (minus 43 degrees).

and minus 47 degrees. In this case, two balls are labeled as one pattern. The radius ratio and the roundness are 20.71083 and 1.98948 respectively. If this bridge connects two balls completely, we can observe this bridge in any inclination angle. In this case, it is considered that two balls have excess solder under the solder ball and we can observe the bridge in the penetration angle between minus 43 degrees and minus 50 degrees. It is reasonable that the radius ratio and the roundness of a solder ball are effective to detect the solder ball bridge based on X-ray image data. Besides, we can detect defects under the solder ball by changing the inclination angle of X-ray.
